**CAMSHAFT TICK NOISE—3.0L 4V ENGINE ONLY
WITH EXHAUST CAMSHAFT DRIVEN WATER PUMPS**

TSB 08-3-10

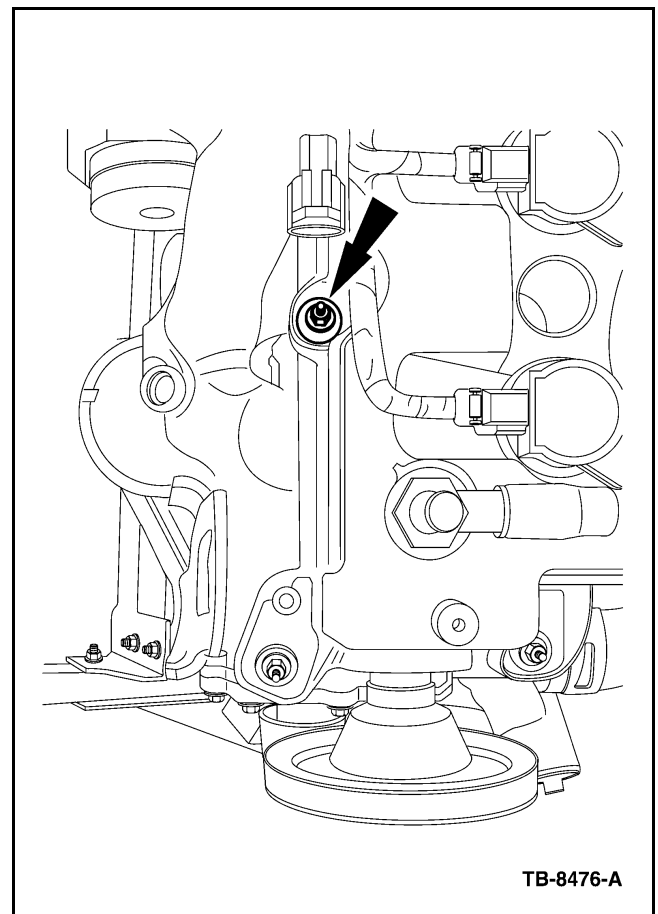
Figure 1 - Article 08-3-10

Some 2005-2007 Five Hundred, Freestyle, Montego, and 2006-2007 Fusion, Milan, 2006 Zephyr, 2006-2008 Escape and Mariner vehicles built 1/17/2006 thru 5/31/2007, equipped with the 3.0L 4V Duratec engine with exhaust camshaft driven water pumps may exhibit a ticking noise from the left bank cylinder head with the engine at normal operating temperature.

To diagnose, with the engine running and warm (normal operation temperature), using a mechanic's stethoscope, determine if ticking noise is coming from the left hand exhaust camshaft at cylinder number 6 (Figure 1). If ticking noise can be verified, refer to the following Service Procedure.
